Roles and Responsibilities for Local Flood Risk Management

Manhood Peninsula SWMP

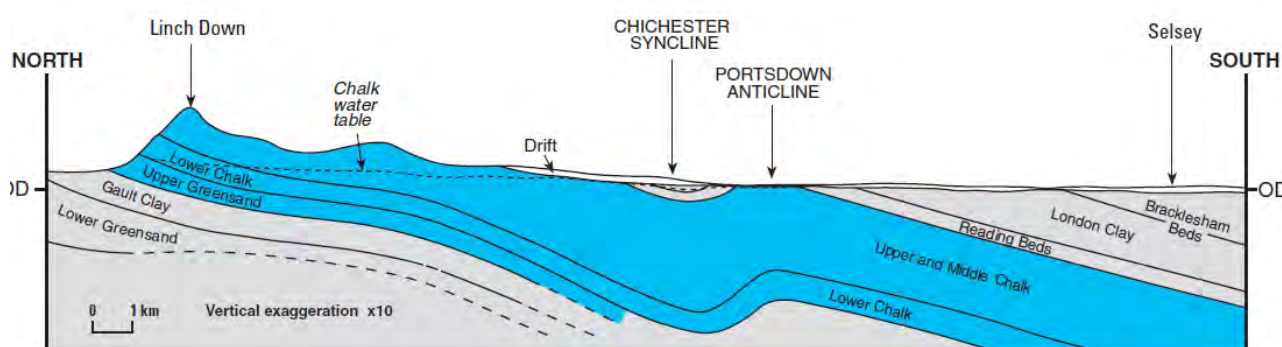
Figure 3.1 Generalised regional geological section through Chichester and across the Manhood peninsula. Note that some of the geological nomenclature used on the cross section has now been superceded. (From: “The Chalk Aquifer of the South Downs”. Hydrogeological Report Series of the British Geological Survey. British Geological Survey 1999).

The regional geological setting of the Manhood Peninsula is significantly influenced by its geological structure. The general southerly dip of the Chalk is subject to significant folding comprising primarily the “downfold” of the Chichester syncline and the associated “upfolds” of the Portsdown and Littlehampton anticlines. This is illustrated in Figure 3.1 below.

As a result of this structure the extreme northern part of the study area is underlain by Chalk strata of Cretaceous age, where it has been brought to the surface by folding. In this area the Chalk near the surface is overlain by superficial River Terrace Gravel and Alluvial Fan deposits (see below). The Chalk mapped in this area is undifferentiated between the various different chalks of the White Chalk Sub Group, as described in Table 3.1 below.

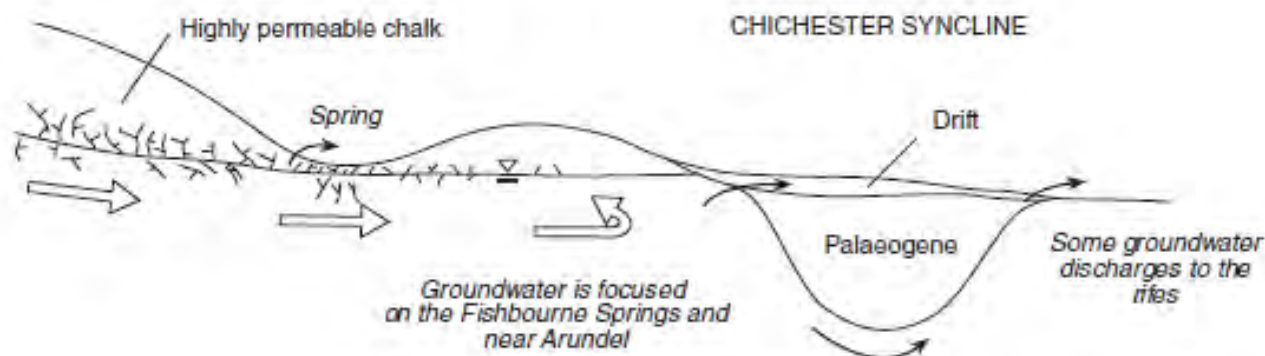
Figure 3.4. The effect of the Chichester Syncline on regional groundwater flow. (From: "The Chalk Aquifer of the South Downs". Hydrogeological Report Series of the British Geological Survey. British Geological Survey 1999).

Regionally, the Chichester Chalk aquifer is recharged by rain falling on the Lavant catchment, north of Chichester. The synclinal fold structure of the Chalk beneath Chichester, described above, is such that southerly groundwater flow from the recharge area to the north is effectively diverted in both easterly and westerly directions. Significant springs discharging this groundwater emerge at Fishbourne Springs, to the north western end of Chichester Harbour, where the Chalk lies directly beneath a relatively thin and permeable drift cover of superficial deposits. Further springs derived from this regional groundwater flow emerge as far east as Arundel and as far west as Beckhampton. This is illustrated by the conceptual section in Figure 3.4 below.

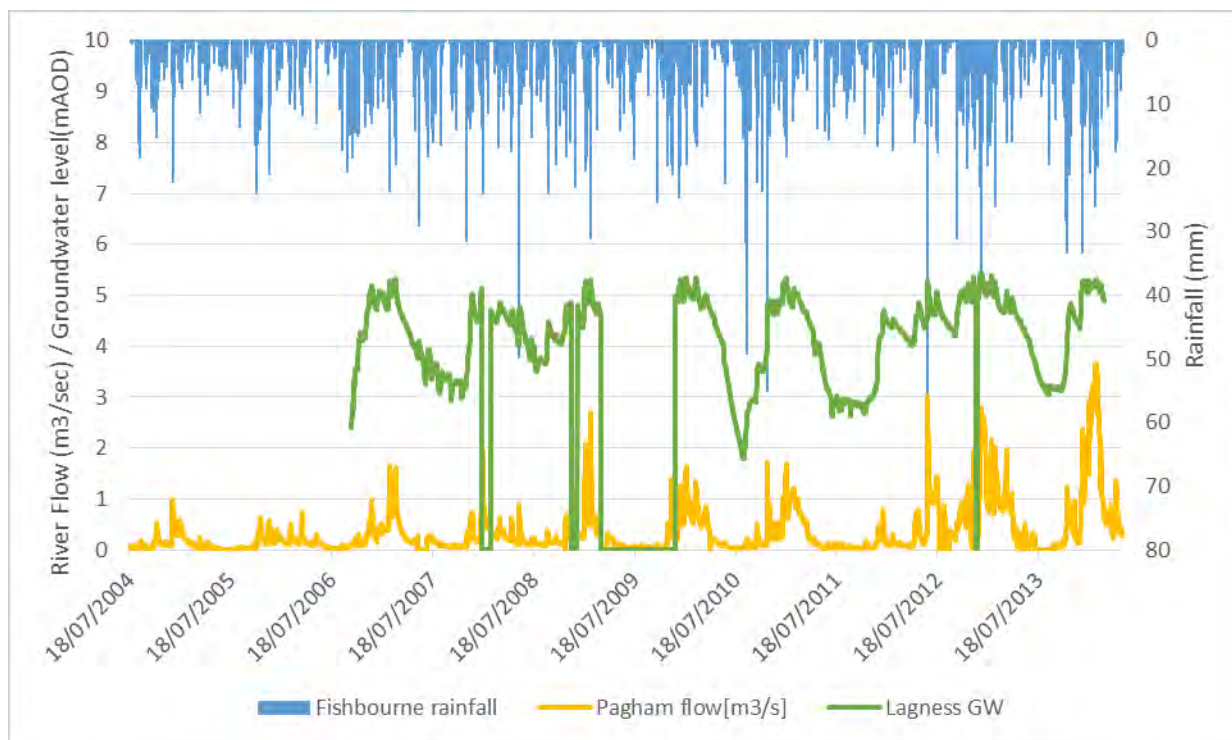
Figure 3.5 Groundwater levels at Lagness, Pagham Rife Flow and Fishbourne rainfall

Groundwater level information from the Chalk aquifer was available from an EA monitoring borehole at Lagness, about 2km east of South Mundham. The Chalk in this location is at about 20m depth, and the aquifer is confined by the overlying Reading Formation. The level data (groundwater hydrograph) is shown on Figure 3.5 below together with surface water flow (flow hydrograph) measured in Pagham Rife and rainfall (monitored at Fishbourne).

Notably the maximum groundwater levels recorded (at Lagness) each winter for the period of the record appear relatively consistent during each winter, and there is no significant or anomalous peak in the data during the winter of 2013/2014, as has been recorded elsewhere in West Sussex. This is somewhat curious, but may reflect the confined condition of the groundwater in this location and the fact that significant groundwater discharge occurs further north (as described above in section 3.2a).

The surface water flow in Pagham Rife (gauged toward its downstream end) may also be compared with groundwater levels at Lagness – the correlation does not appear to be that good (e.g. winter groundwater levels in 2006, 2009, 2010 do not appear significantly different to those from 2014 whereas there is a significant difference in the winter flows in Pagham Rife for these periods (though see note below)). On this basis, it would therefore appear that flows in Pagham Rife are not that closely related to groundwater levels in the Chalk beneath the northern and eastern part of the peninsula.

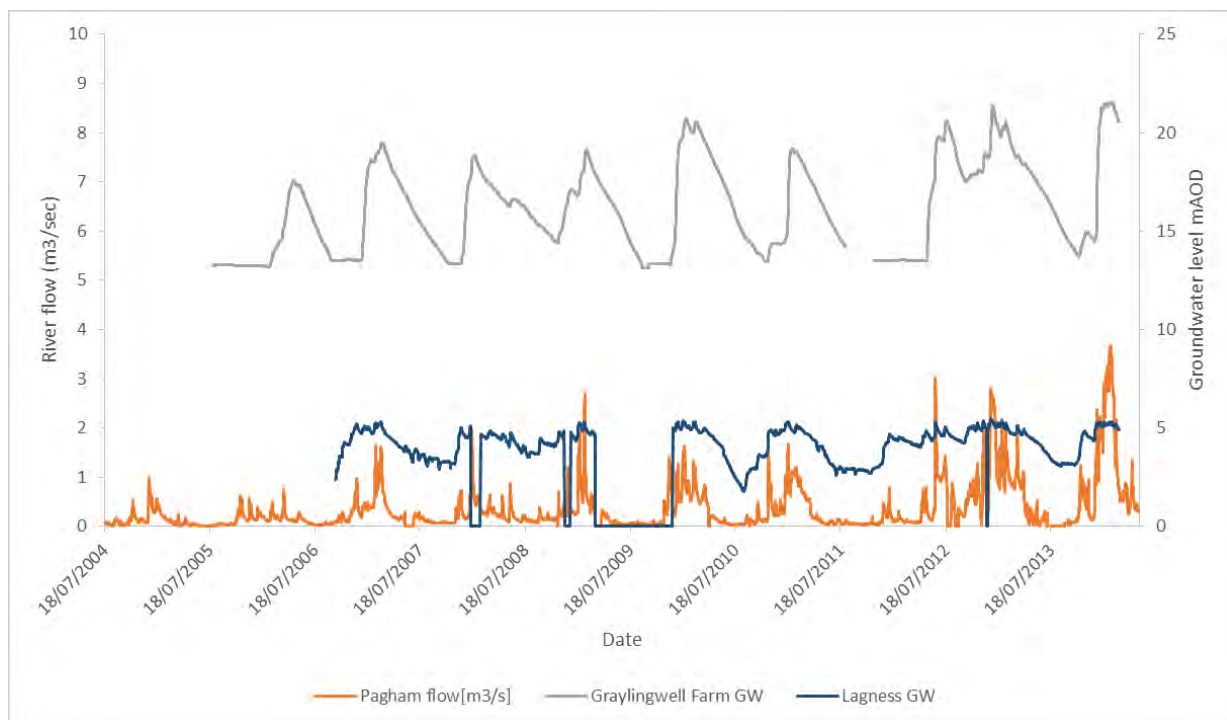
Figure 3.6 Pagham Rife Flow vs Groundwater levels at Lagness and Graylingwell

The relationship between more regional groundwater flow and flows in Pagham Rife is however more revealing. If groundwater monitoring from the Graylingwell monitoring station (north east of Chichester) is compared with Pagham Rife flows, arguably there is a more direct correlation, as shown in Figure 3.6 below. For example, Graylingwell, when considered in the context of seasonal water level fluctuations, shows a markedly lower groundwater level in 2005/2006 than in 2014 (more in line with Pagham Rife Flows) and there appears to be a much better correlation throughout.

This information would seem to suggest that flows in Pagham Rife are quite closely related to the Chalk groundwater and hydrological regime to the north of Chichester and that regional Chalk groundwater flow could contribute to baseflow in the upper (north east) part of the Pagham Rife catchment (i.e. the Forebridge Rife), for example emerging through the River Terrace Gravels east of Runcton. However there does appear to be only a relatively limited reach (circa 1km) through which this could occur, so this direct baseflow contribution from the Chalk to the Forebridge Rife may be relatively limited.
